Manhole Inspection Summary

Manhole # S04AA2005MH

Insp Date: **6/26/06 9:24 AM**

Location Address: **3600 CLARKS LN**

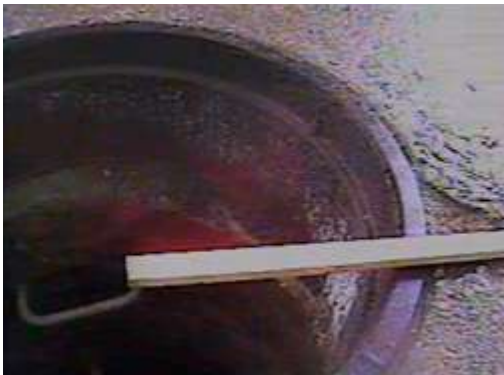
Defect

Frame Offset: **2** (in.)

☒ **Leaks**

Infiltration: ☐ None ☒ **Joint** ☐ Cracks ☐ Mortar ☐ Roots ☐ Wall

Frame leaks. Frame offset. Adjustment infiltration.

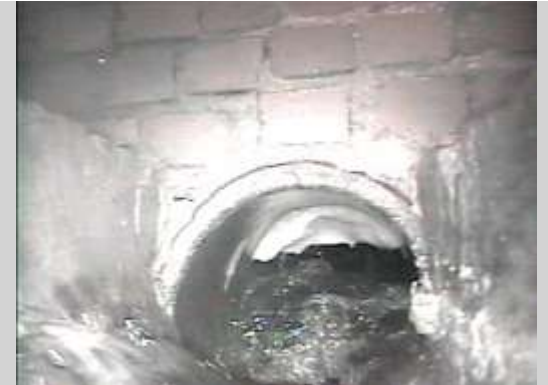
10 in. Circular Gravity Sewer Pipe Out @ 12 O'Clock

Infiltration: **None** Pipe Seal Cond: **Unknown**

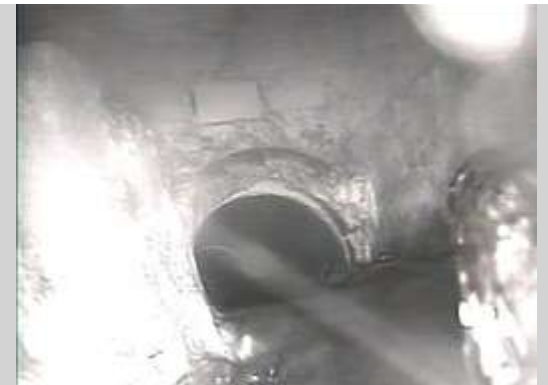
8 in. Circular Gravity Sewer Pipe In @ 5 O'Clock

Infiltration: **Evidence** Pipe Seal Cond: **Unknown**
